**Biodiversity Action Plan (BAP)**  
**Buchanan–Cestos City Junction Road Corridor (60.9 km)**  
**Mano River Union Road Development and Transport Facilitation Programme**  
**(MRU/RDTFP)-Liberia**

**Version 1.0 – For Submission to AfDB**

**Date: January 23, 2026**

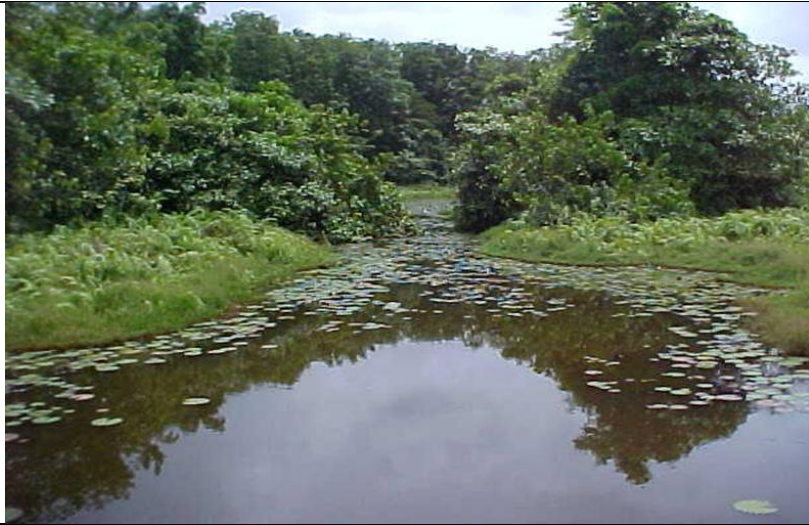
*Wetlands with Water Hyacinth along Benson River near Buchanan City*

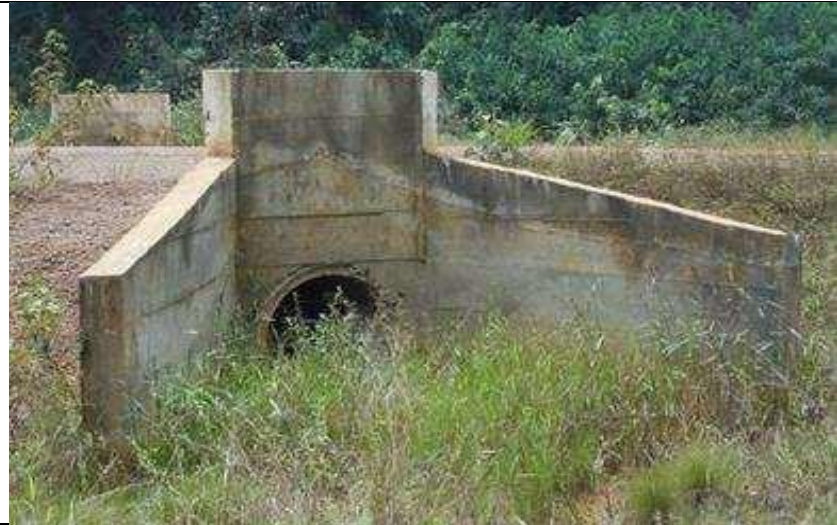
Existing drainage structures along the Buchanan–Cestos corridor showing reinforced concrete and culvert drainage systems, some of which are partially obstructed by vegetation and sediment, potentially affecting water flow and aquatic habitat conditions

Failure to maintain culverts at SC-01–SC-08 and drainage channels near WD-01–WD-06 could result in localized blockage and altered water flow. Routine inspection and maintenance during operation are required to sustain hydrological continuity. Properly functioning drainage systems are expected to reduce long-term erosion compared to existing gravel conditions.
